# Nissan Rogue 2015 to 2020 Blend Door Modification Fix

## **Disclaimer and Warranty**

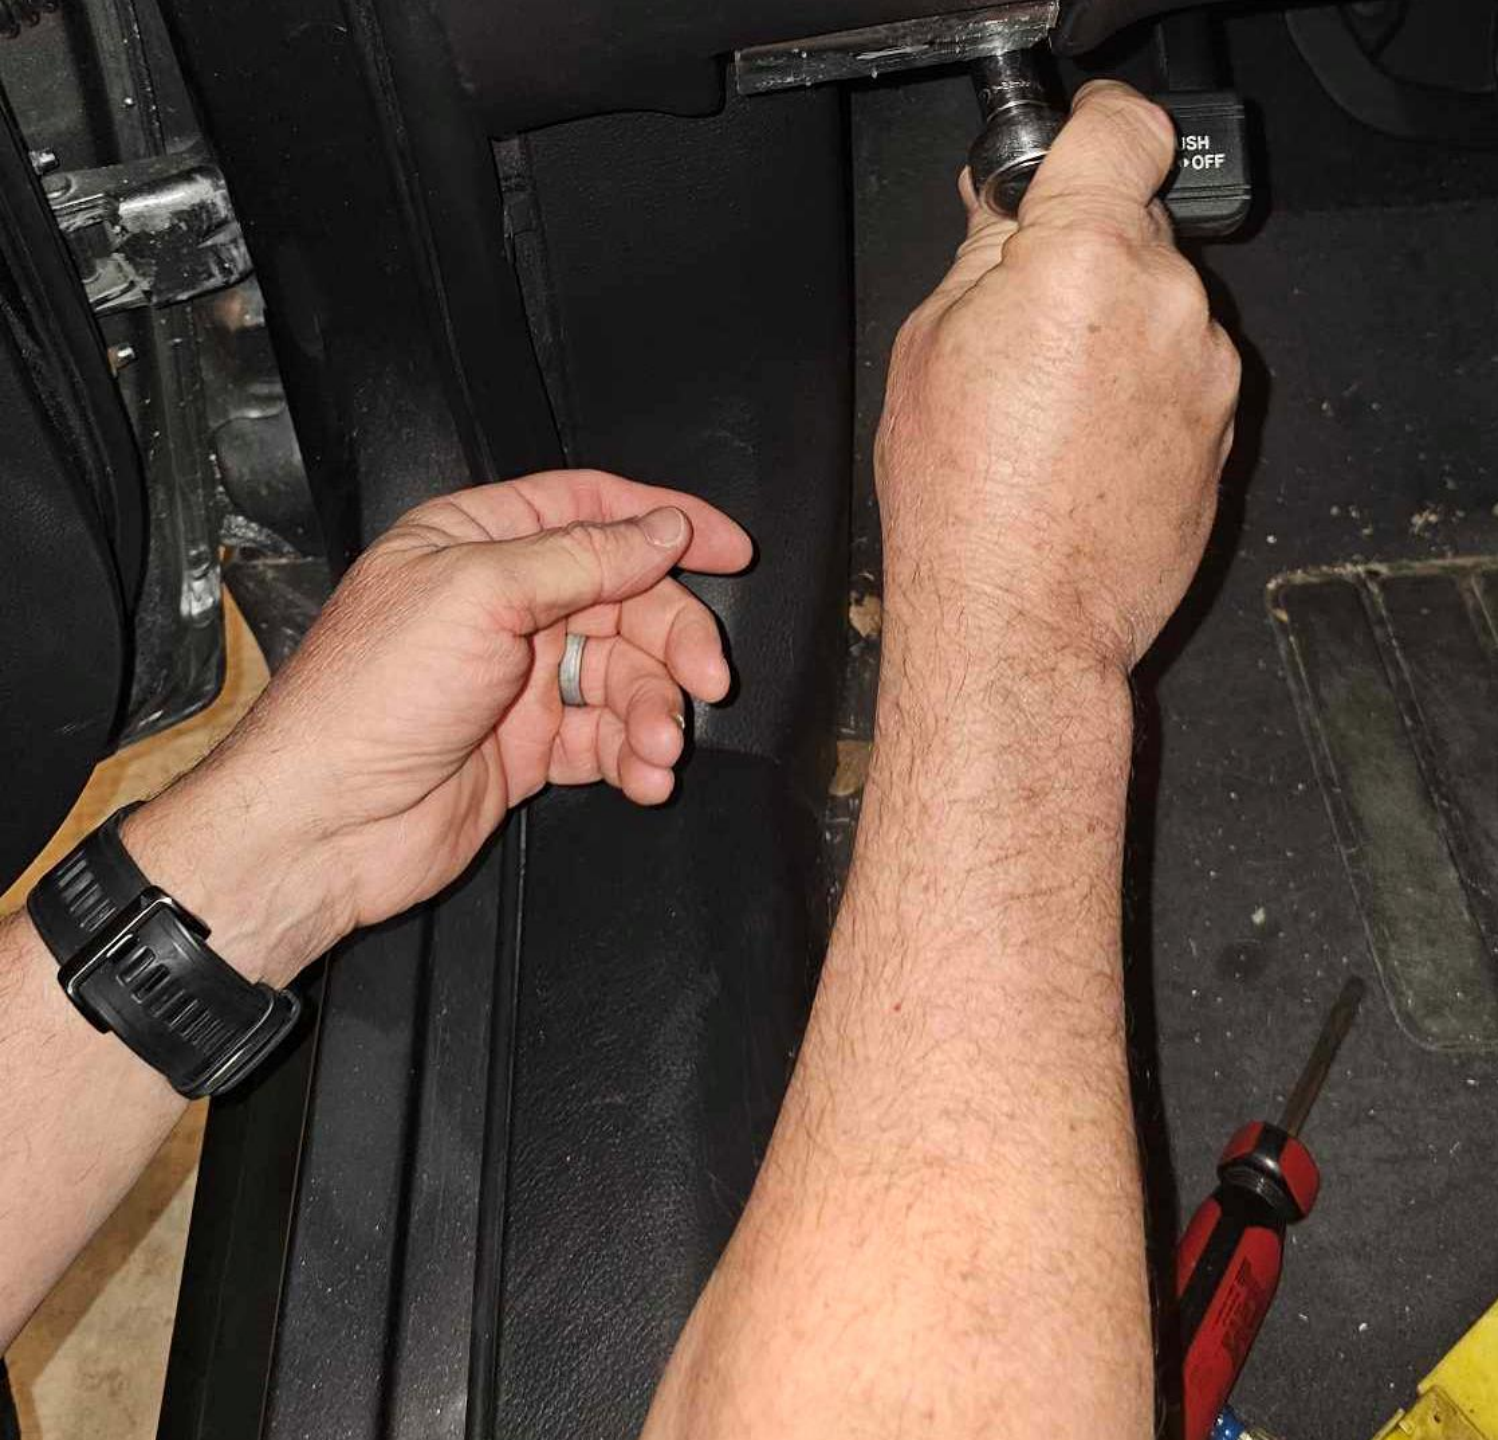
Step1- Remove Fuse  
Cover

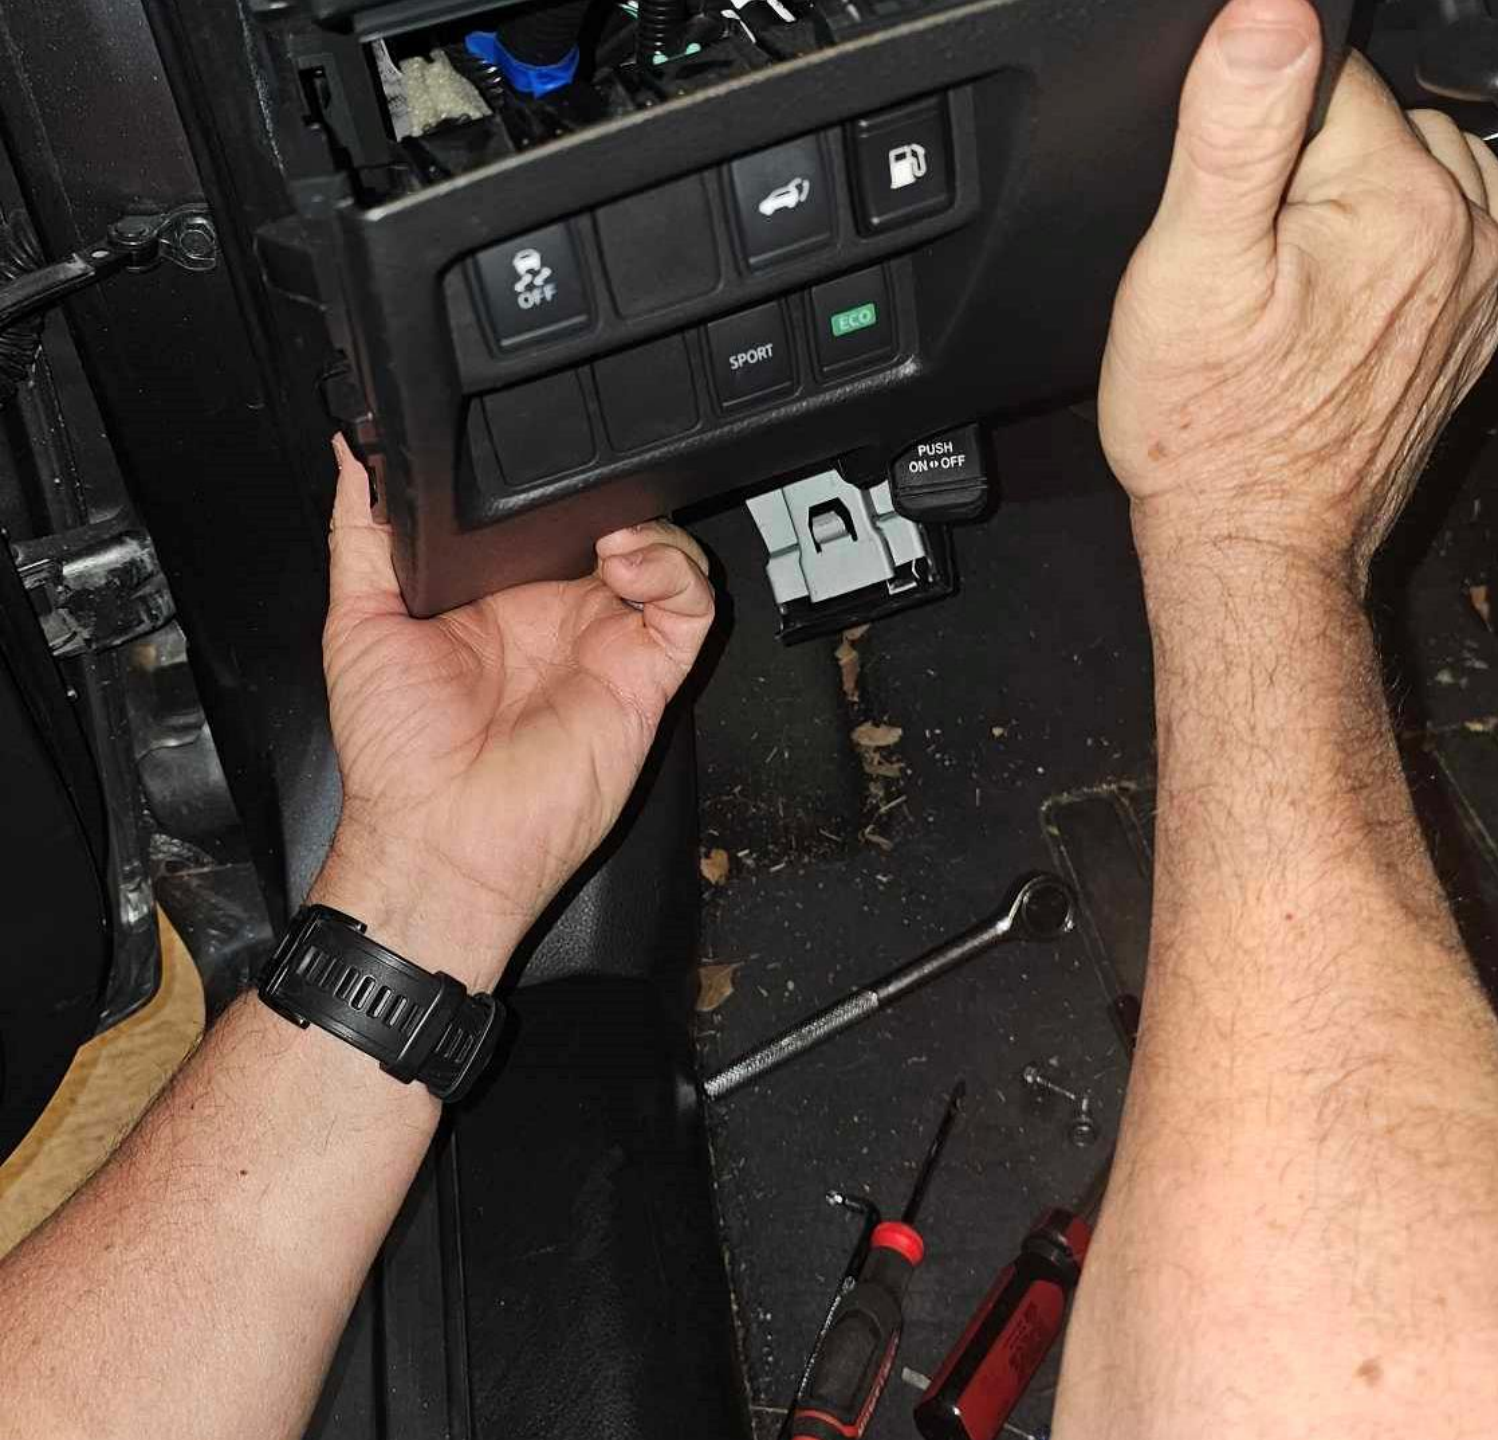
Step2- Remove  
two 10mm  
bolts for  
release lever  
and let it drop  
down:

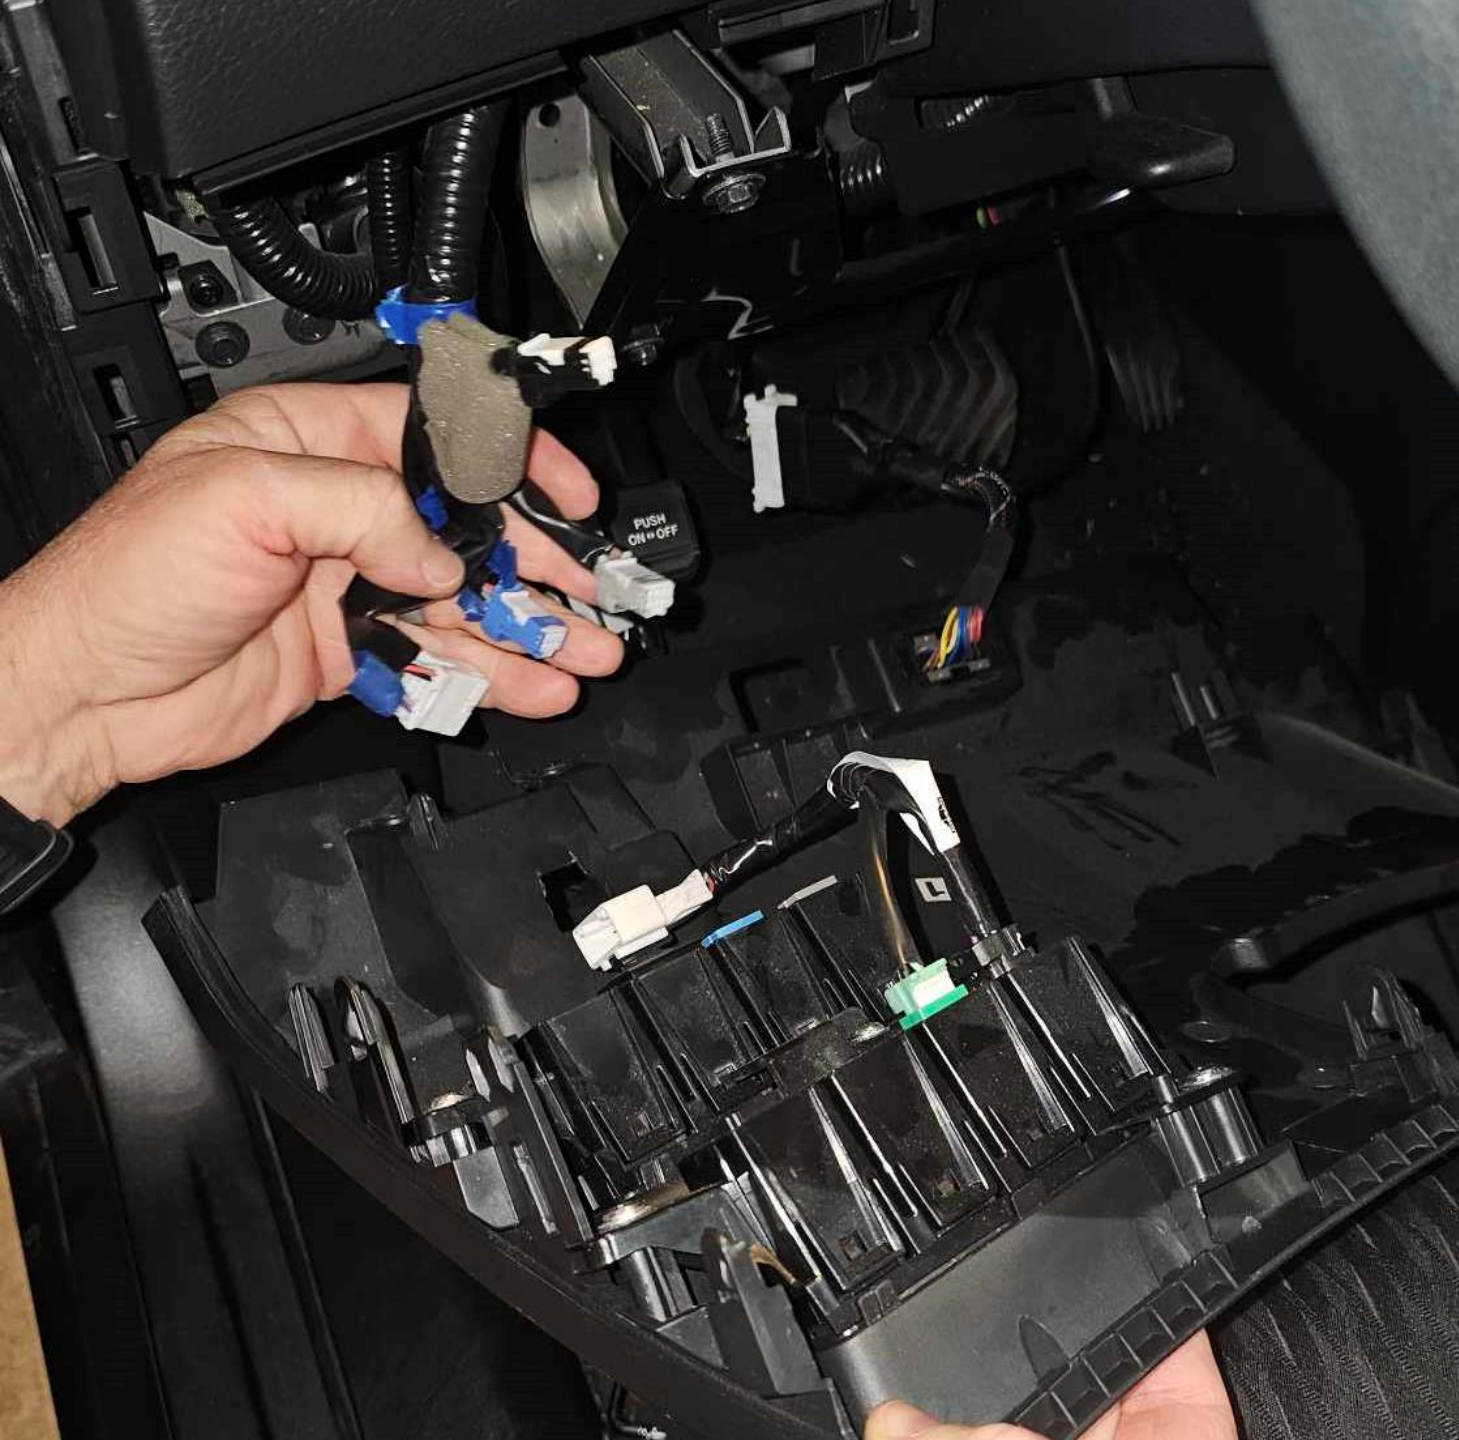
Step3- Remove lower cover, this piece has no bolts and just snaps out. Work its way loose all the way to the center console:

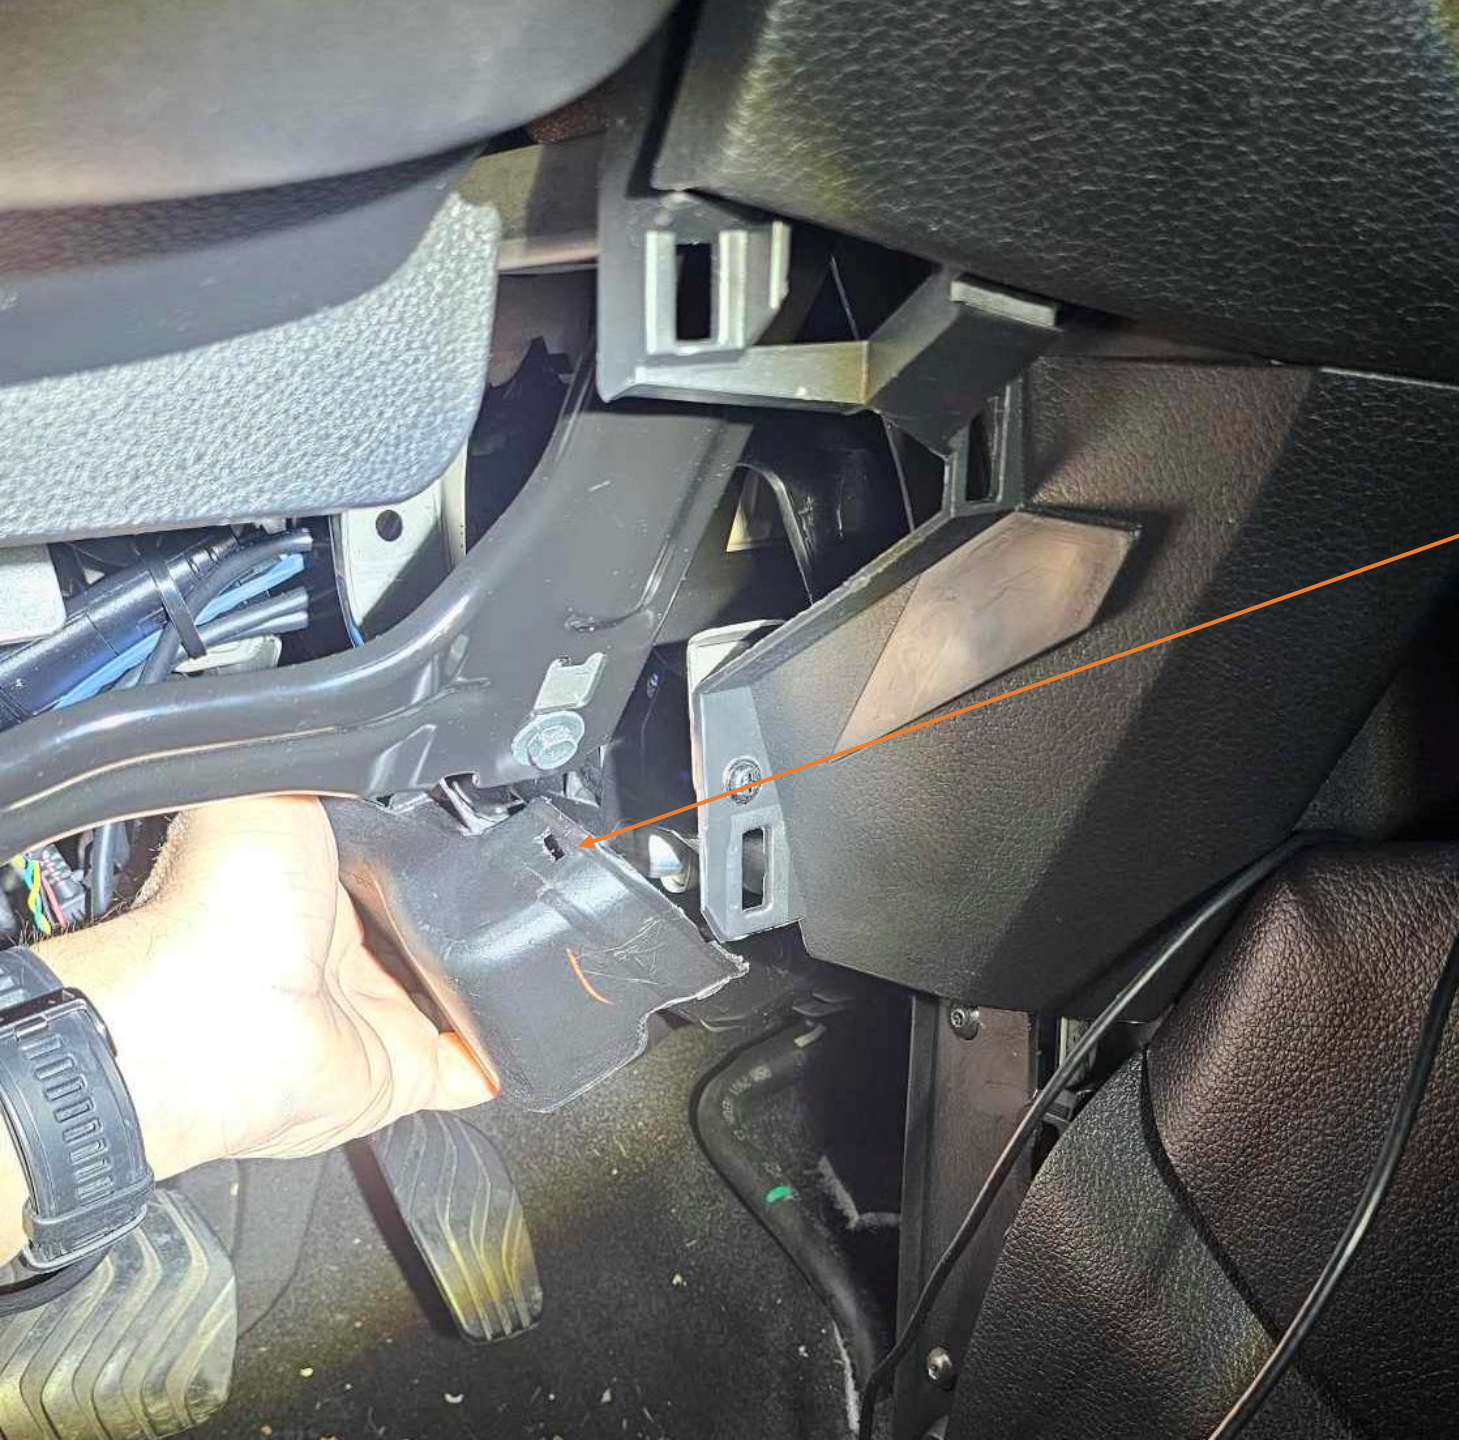
Step5-Remove  
lower center  
console cover.
